TR-959

AN INVESTIGATION OF THE DYNAMICS
OF THE ELECTROLYTE DISTRIBUTION SYSTEM
IN THE PS502-502A POWER SUPPLY

24 July 1961

DIAMOND ORDNANCE FUZE LABORATORIES
ORDNANCE CORPS • DEPARTMENT OF THE ARMY
WASHINGTON 25, D. C.

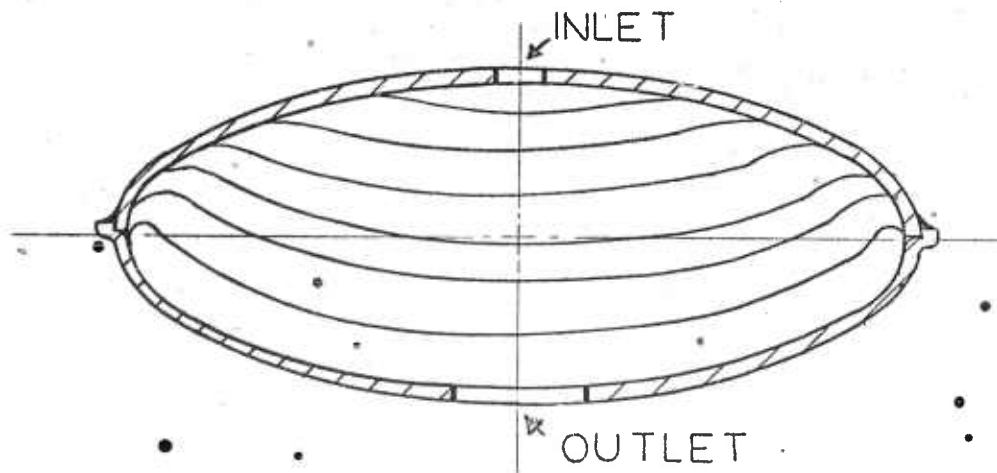
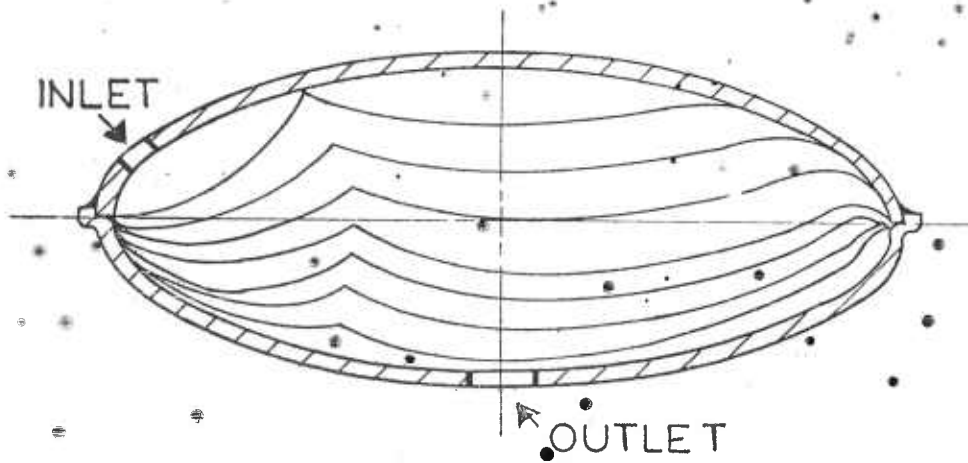
Recent tests have shown that the diaphragm does not fold from the center, but from one edge (at the gas inlet point) and then from the

center (fig. 2). This improper folding results in sharp creases and occasional fracture of the diaphragm, particularly after extreme vibration (ref 2). A highly stressed point where two creases had intersected is shown in figure 3. A failure zone is shown in figure 4. These 10X microphotographs were made of dissected reservoirs taken from expended batteries. Careful examination under higher magnification showed that the failure is entirely mechanical and is not caused by local corrosive action or foreign inclusions (ref 3). Figure 5 shows the location with respect to the gas inlet of diaphragm failures found in 15 batteries from a group of 30 in a recent laboratory test (ref 4).

Figure 2. Proper diaphragm inversion and actual inversion.

- (2) The diaphragms do not fold properly when battery activators (with squibs) are used. This is caused (a) by the high-pressure shock from the exploding squibs and (b) by the location of the point of gas entry. Improper folding is evidenced by the films and by post mortem examinations of reservoirs from batteries with diaphragm failure.

- (1) Move the point of gas entry into the reservoir from the edge toward the axis of the reservoir to allow the diaphragm to fold properly. This could be done without changing the container dimensions if the gas inlets are arranged as in Setup A4 and A5. A single inlet on the axis would require a substantial increase in one dimension.

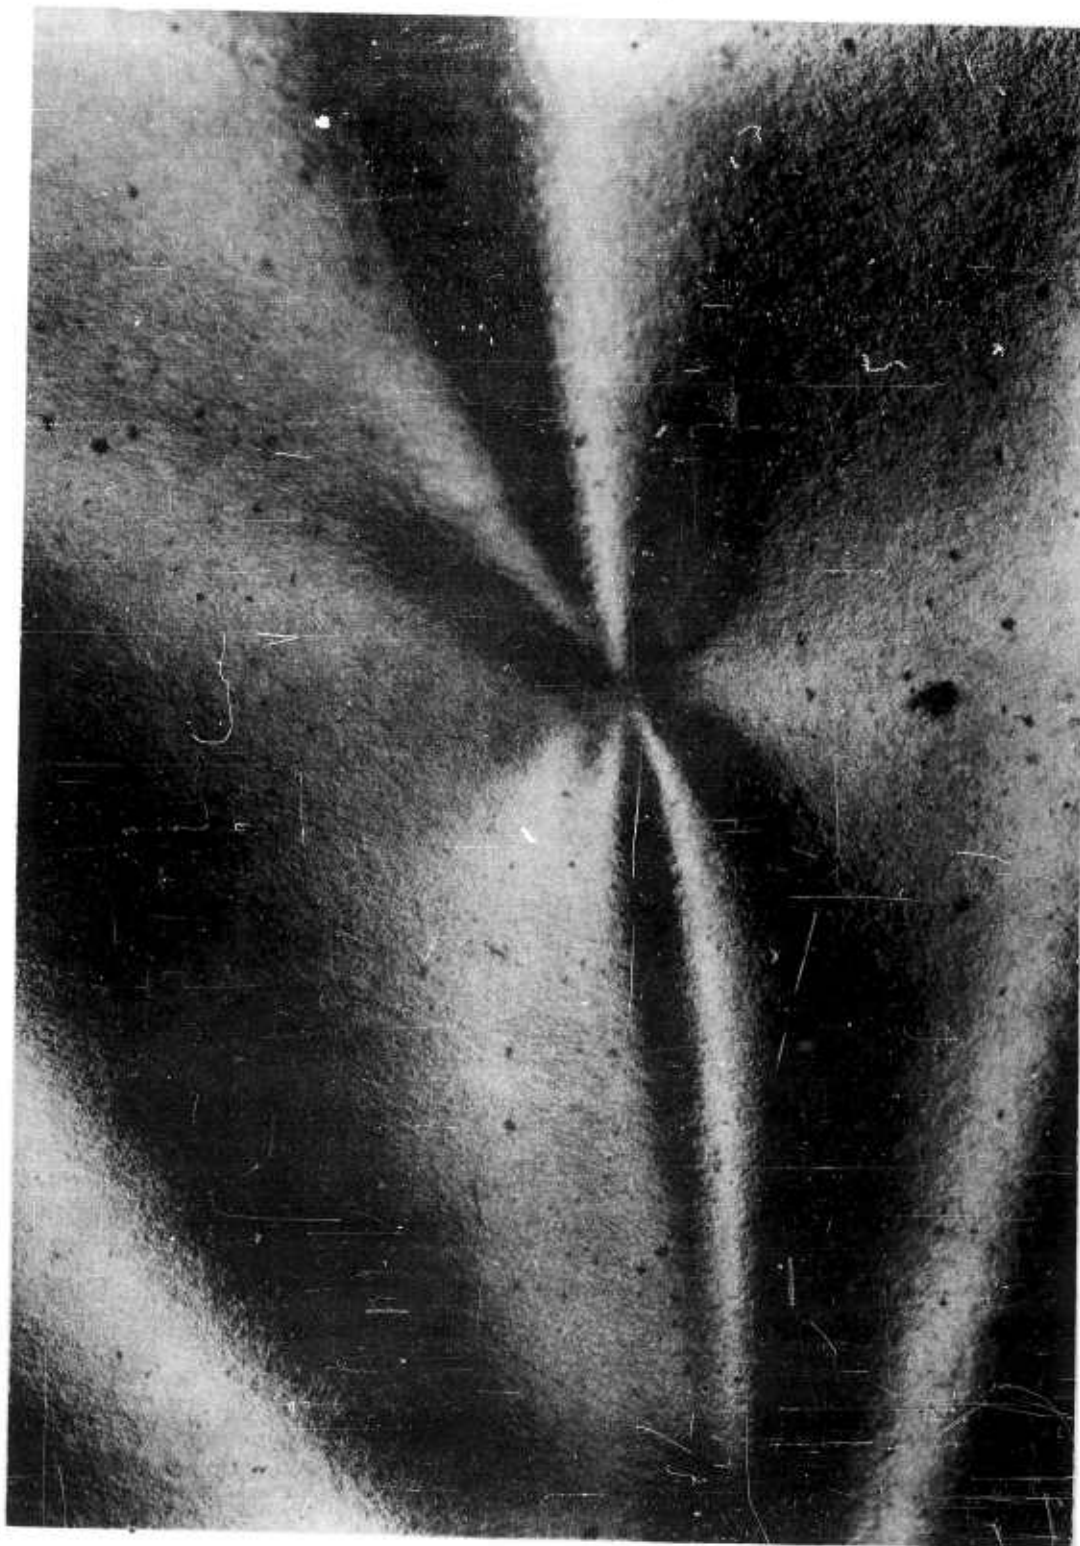
Figure 3. Microphotograph of stressed point in diaphragm - 10X. 998-61

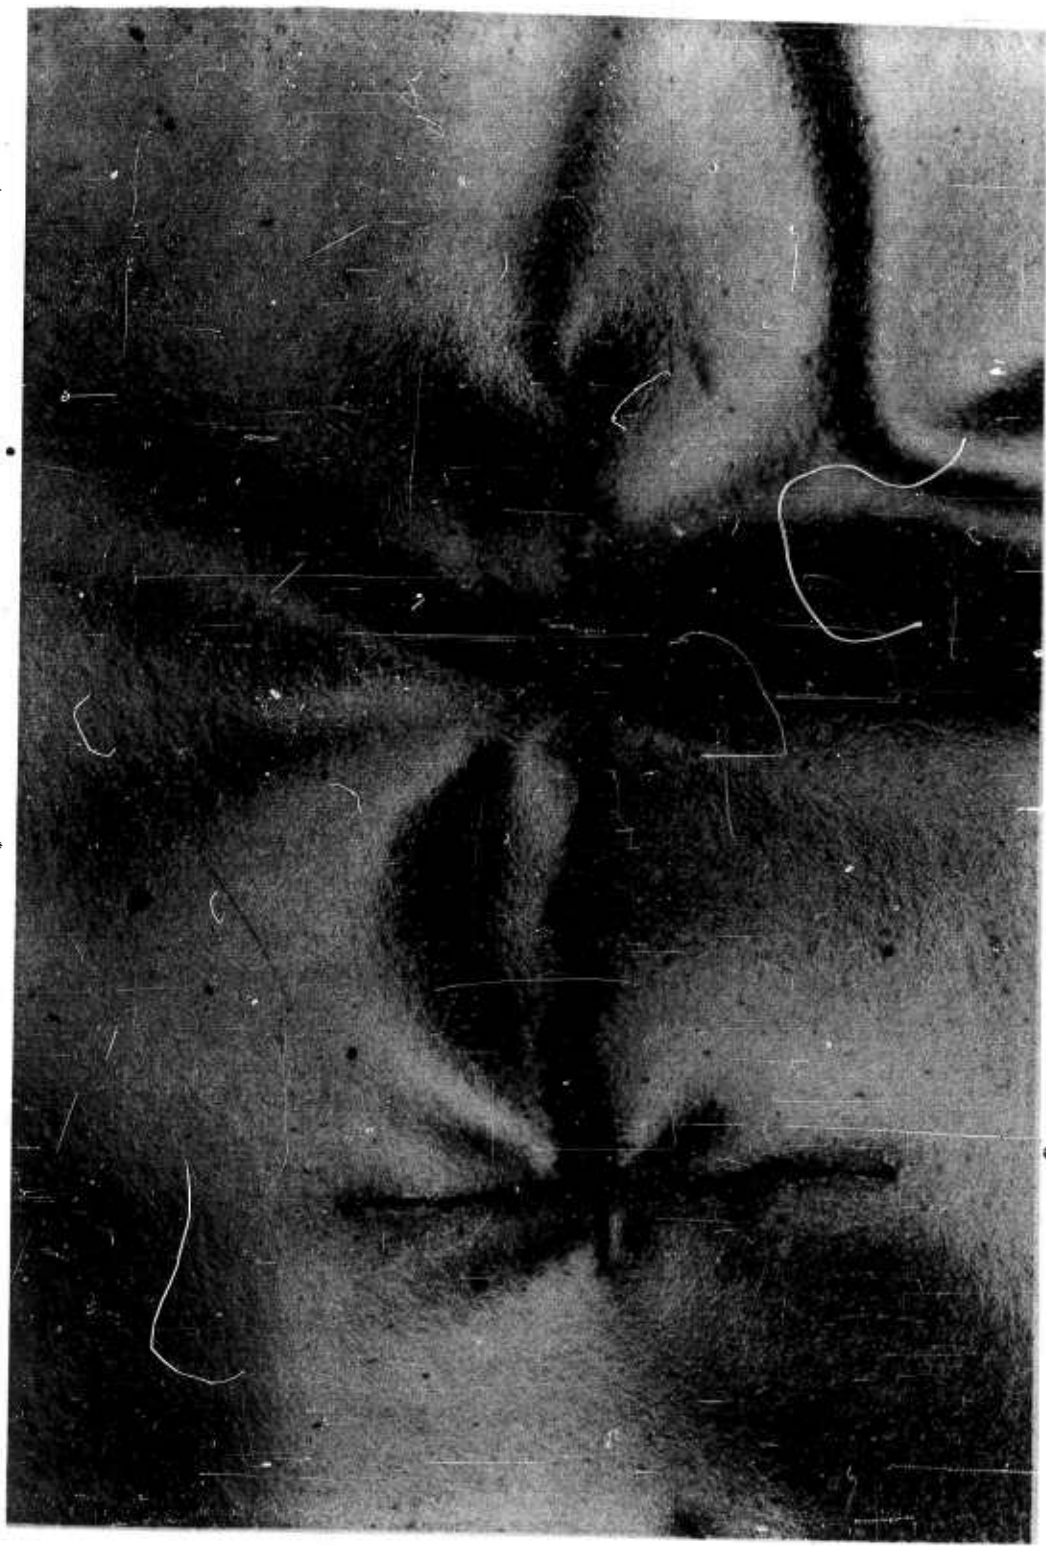
Figure 4. Microphotograph of failure zone in diaphragm - 10X.

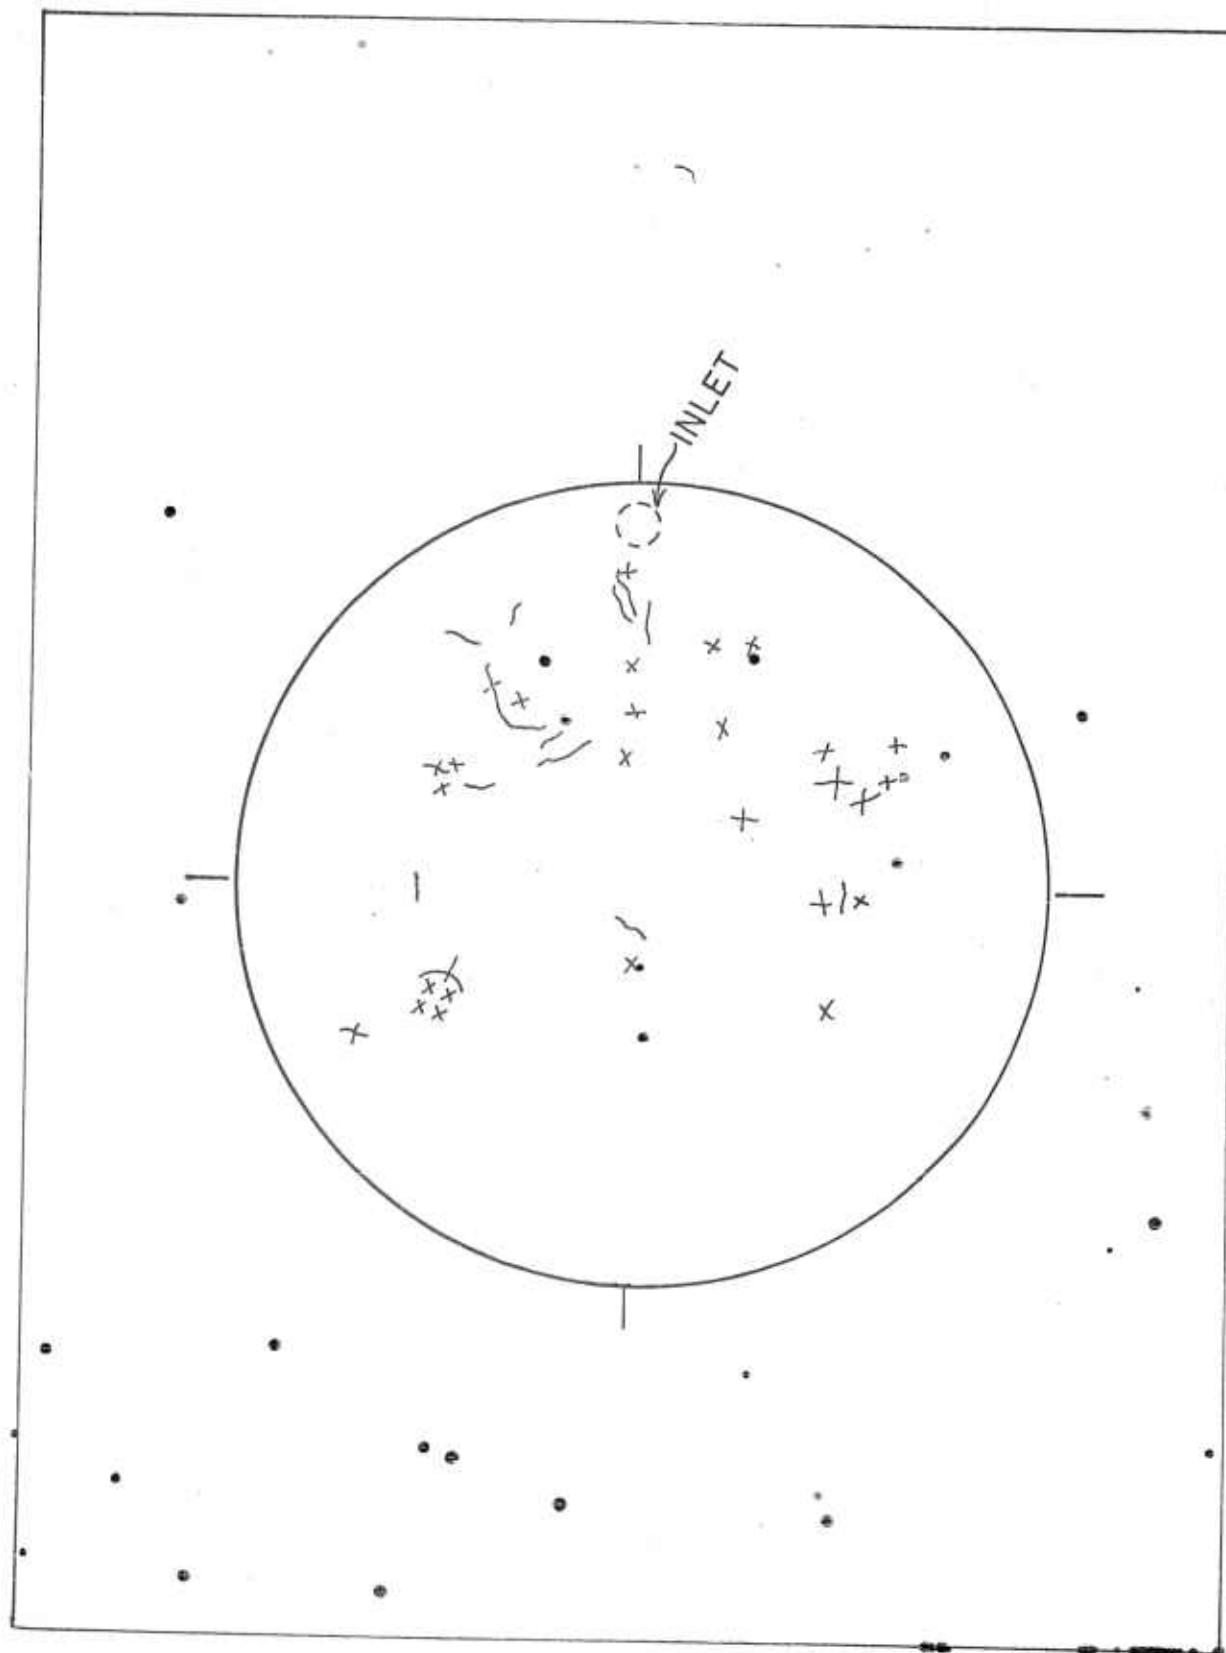
Figure 5. Locations of diaphragm failures compiled from 15 battery post-mortem examinations.

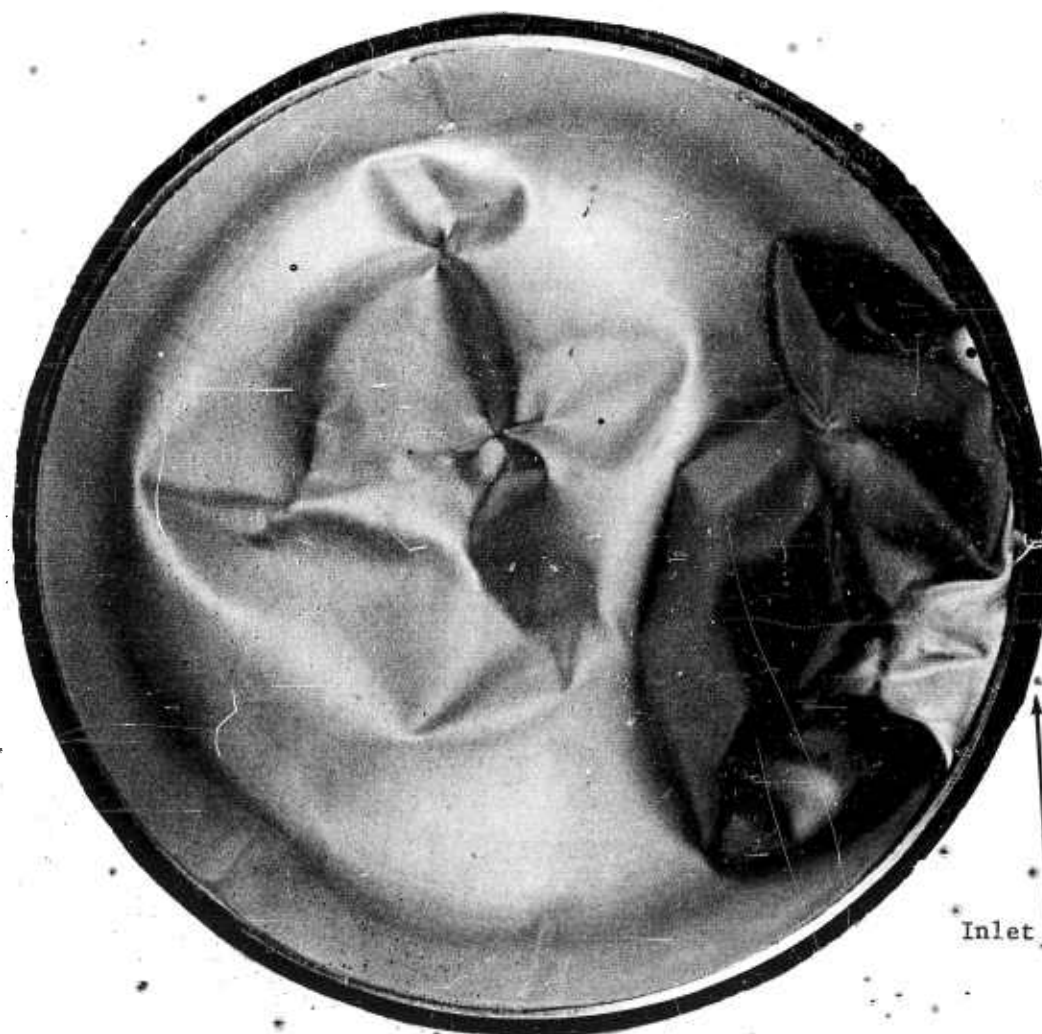
Figure 6. Dissected reservoir showing diaphragm failure. 1. 1638-60

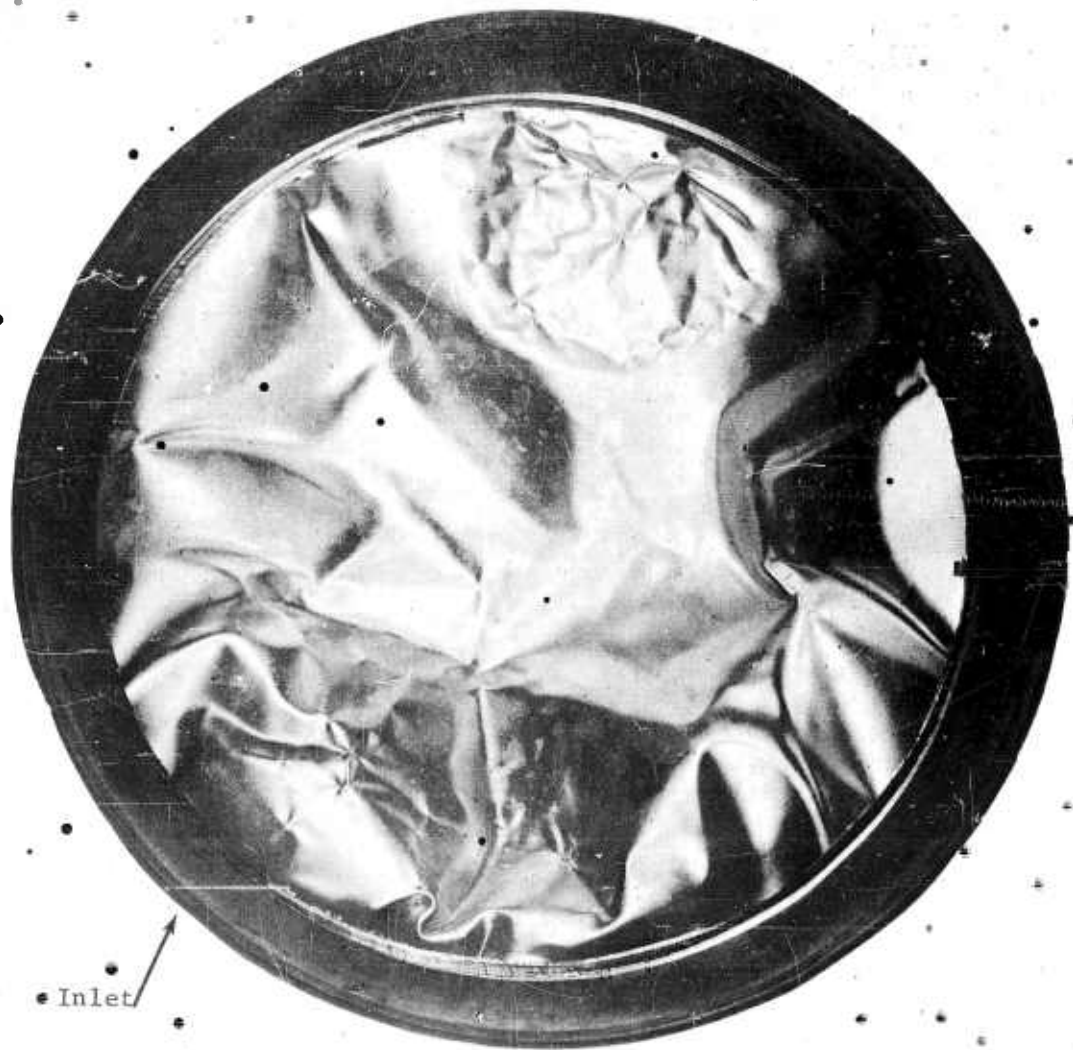
Figure 7. Dissected reservoir showing diaphragm failure, 11.

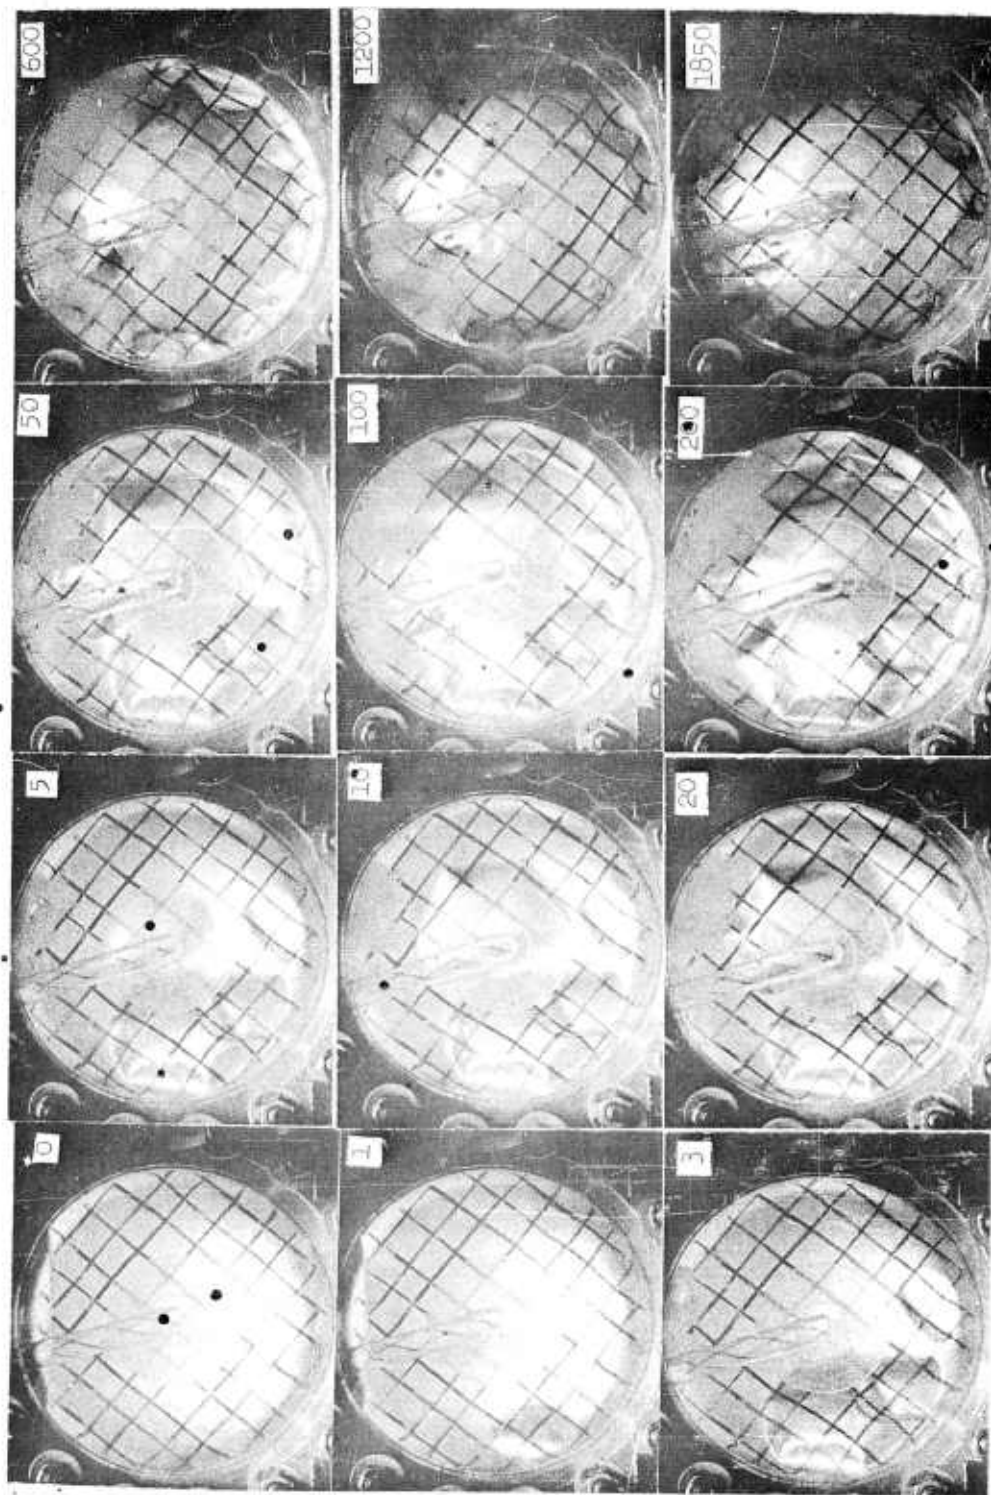
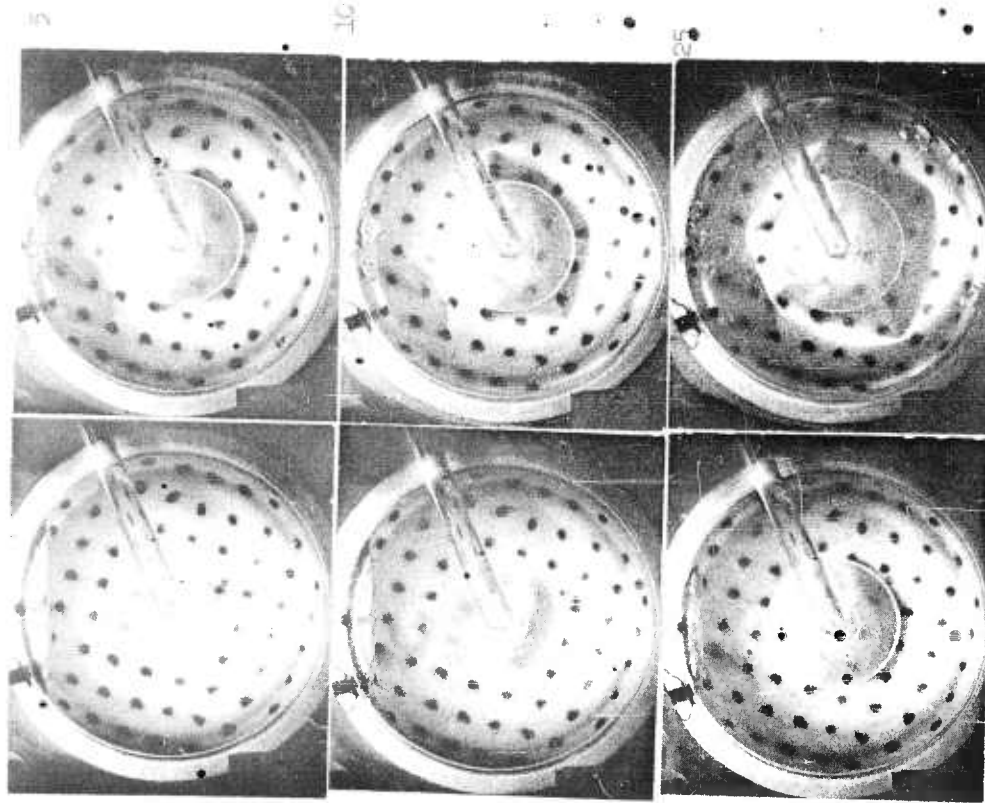
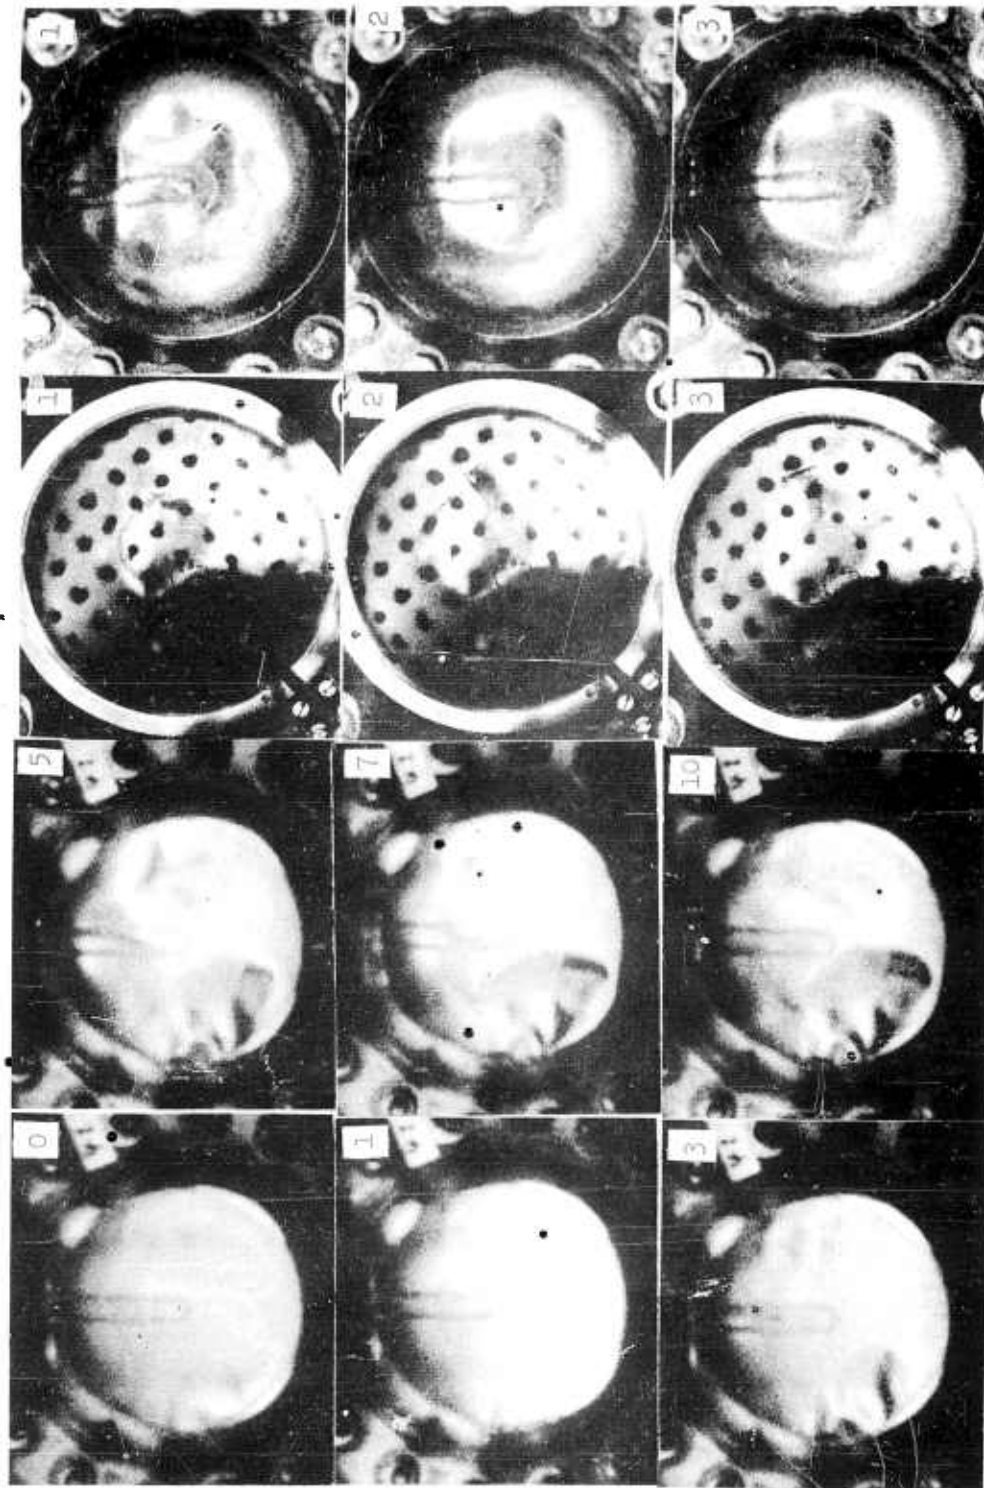
Frames from the films of 5 tests are shown in figures 13, 14, and 15. With the exception of test No. 3 (fig. 15), the tests were all filmed from the liquid side. Test No. 3 shows how the smoke from the squibs obscures part of the diaphragm when the test is filmed from the gas side. Test No. 18, (fig. 13), is typical of the folding action when squibbed activators are used. The initial movement is at the point of gas entry and is followed by inversion near the center. Figure 14, test No. 8, shows proper folding. Here pressurized nitrogen at 500 psi was valved into the reservoir through the inlet at the edge of the reservoir. In figure 15, test No. 42 is of interest because it shows at very high speed the fluttering of the diaphragm caused by the squib detonation (note the temporary blisters in the upper right side). Test No. 42 was performed with the squibbed activator, but the gas inlet diameter was reduced to 0.040 in. The folding is proper.

Figure 13. Folding sequence, test 18, 128 frames per second. 1000-61
 (Numerals identify the frame number.)

Figure 14. Folding sequence, test 8, at 128 frames per second.
(Numerals identify the frame number.)

Figure 15. Folding sequences, tests 42, 3, and 53 taken at 1500, 400, and 400 frames per second.
 (Numerals identify the frame number.)

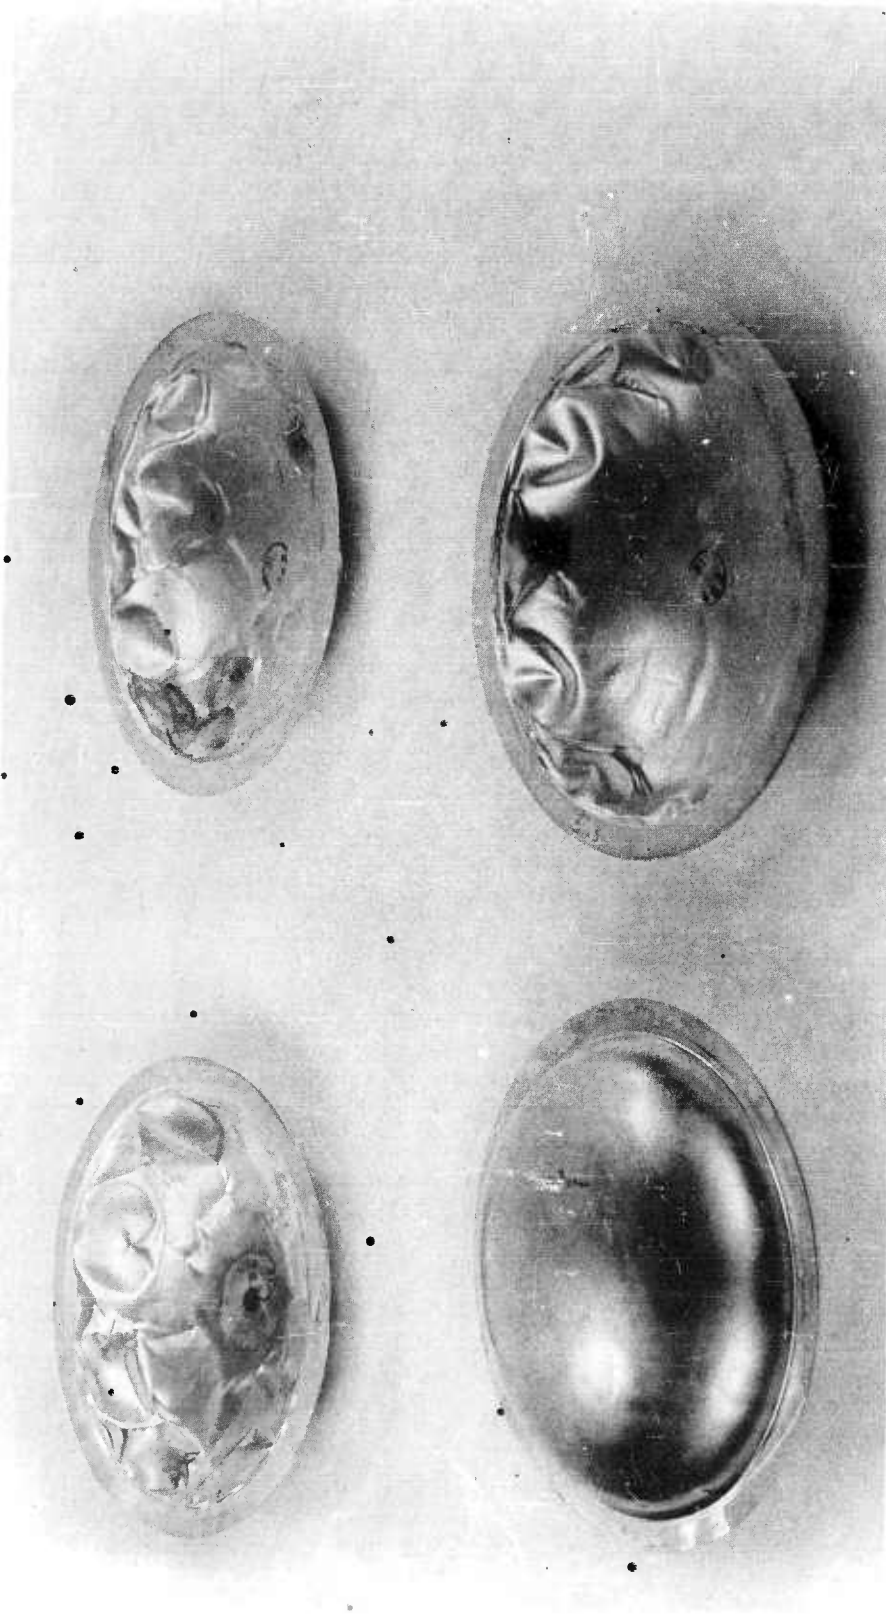
Figure 16 shows one unused and three inverted diaphragms. The dark smudges show the position of the gas inlet before inversion. The smoothness is a function of freedom from liquid leaks during the test. The diaphragms were used in tests 52, 51, and 53, respectively.

Figure 16. Samples of diaphragms before and after folding.

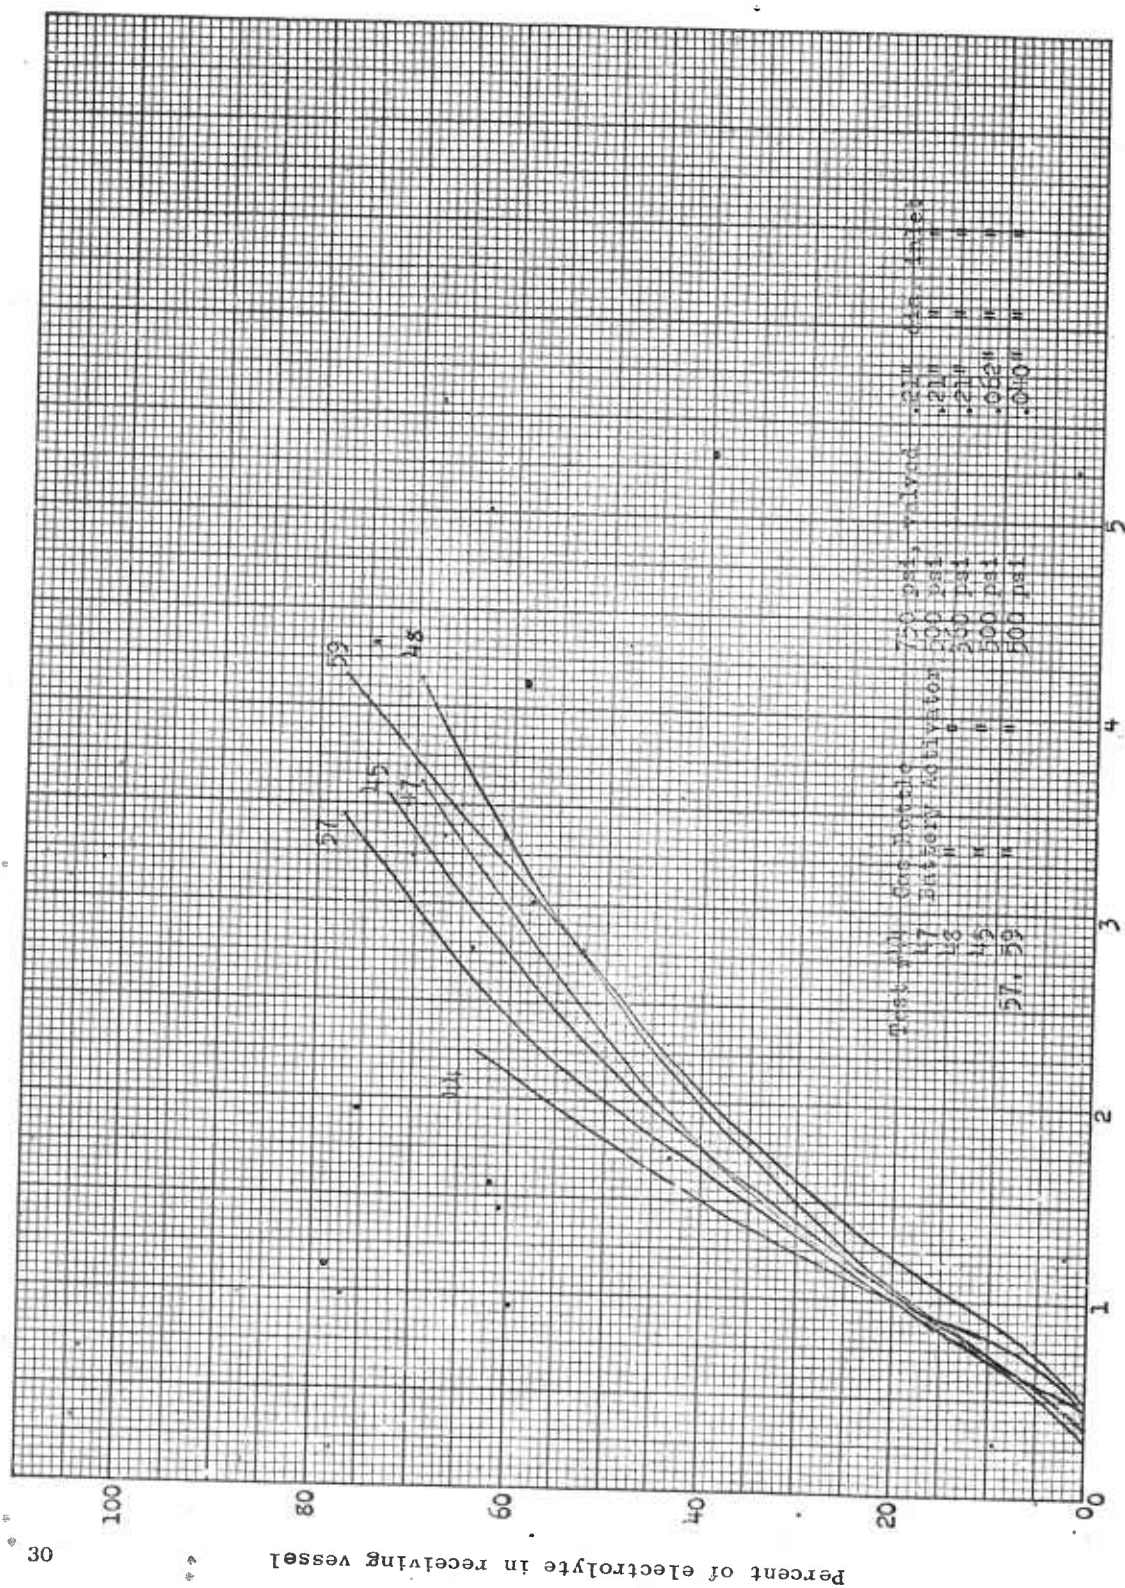
- (4) The electrolyte flow rate is fairly independent of the pressure of the activating gas and whether or not activating squibs are used (fig. 17). The flow rate is controlled by the restriction of the manifold holes and the electrolyte viscosity (no low temperature tests were made here). The electrolyte reaches the cell pack in about 0.5 sec, flows at a reasonably constant rate, and the flow is completed in about 6 sec.

Seconds after initiation.
Figure 17. Electrolyte flow rates with different activators.
